K-Alpha: Adhesion Failure Analysis

Tim Nunney, Thermo Fisher Scientific, East Grinstead, West Sussex, UK

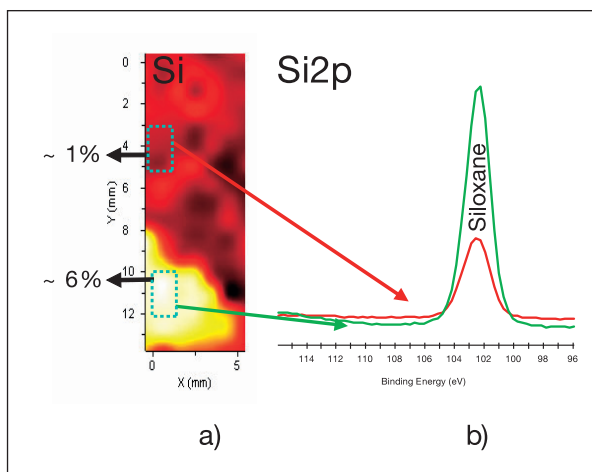
Figure 4: a) Atomic percent map of Si. b) Overlay of average spectra from marked areas.
